INSPECTION REPORT

For the Property at:
SOMEWHERE
CALGARY, AB

Prepared for: A Happy Client
Inspection Date: Monday, March 8, 2010
Prepared by: Tom Connell

RE: Report No. 1004, v.2
Somewhere.
Calgary, AB
T2J XXX

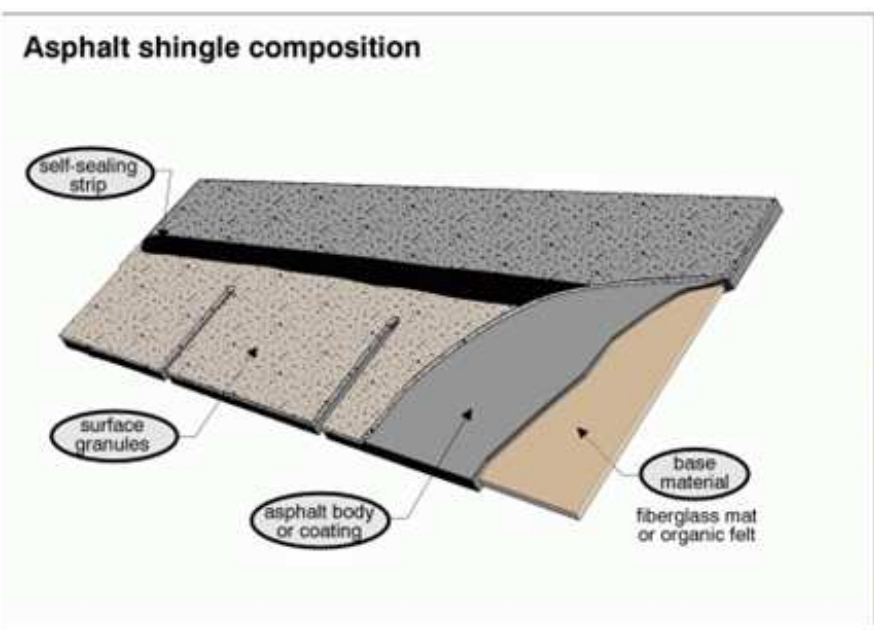
SLOPED ROOFING \ Asphalt shingles
Condition: [Granule loss](#)
Granule loss and start of curling on south/west side of garage roof
Implication(s): Chance of water damage to contents, finishes and/or structure
Location: Southwest Exterior Garage
Task: Replace
Time: Less than 2 years

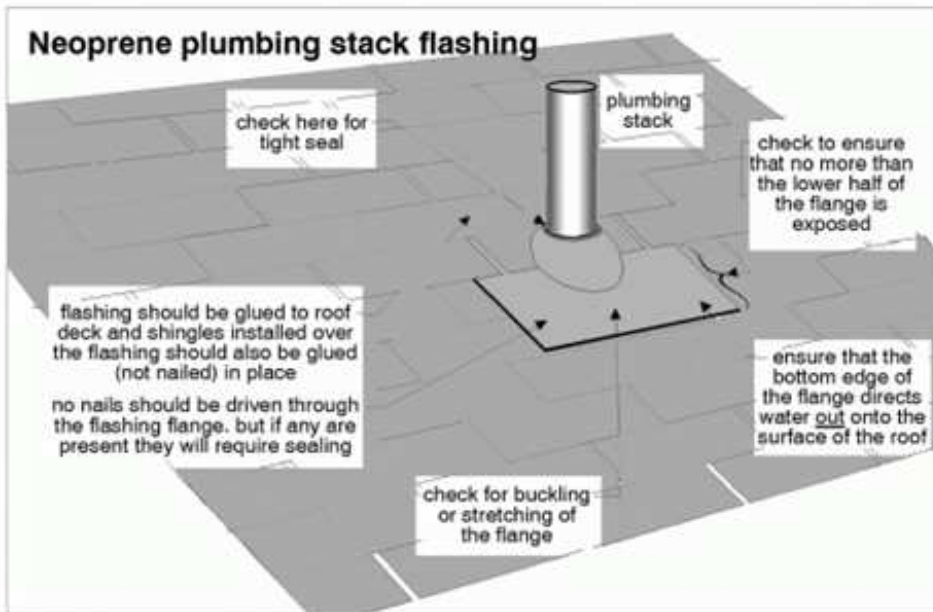
SLOPED ROOF FLASHINGS \ Pipe/stack flashings

Condition: [Exposed, missing fasteners](#)

Implication(s): Chance of water damage to contents, finishes and/or structure

Task: Improve

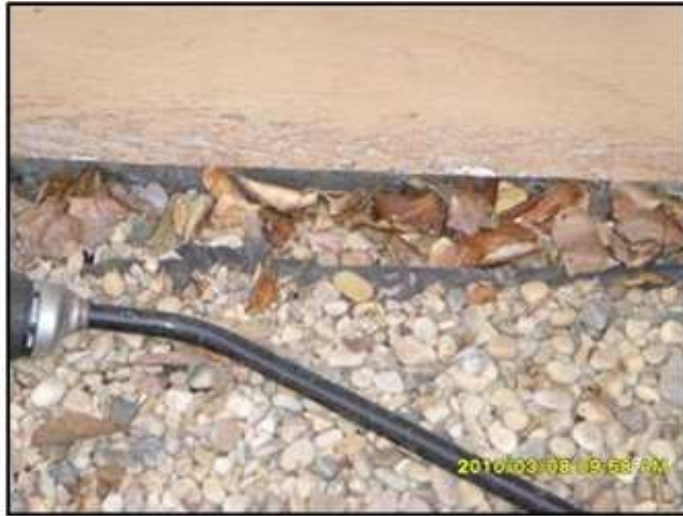
2.

WALLS \ Wood siding

Condition: [Rot or insect damage](#)

Boards are too close to grade level on both sides toward the rear of the house.

Implication(s): [Cosmetic defects](#) | [Chance of water damage to contents, finishes and/or structure](#) | [Material deterioration](#)

Task: [Improve](#)

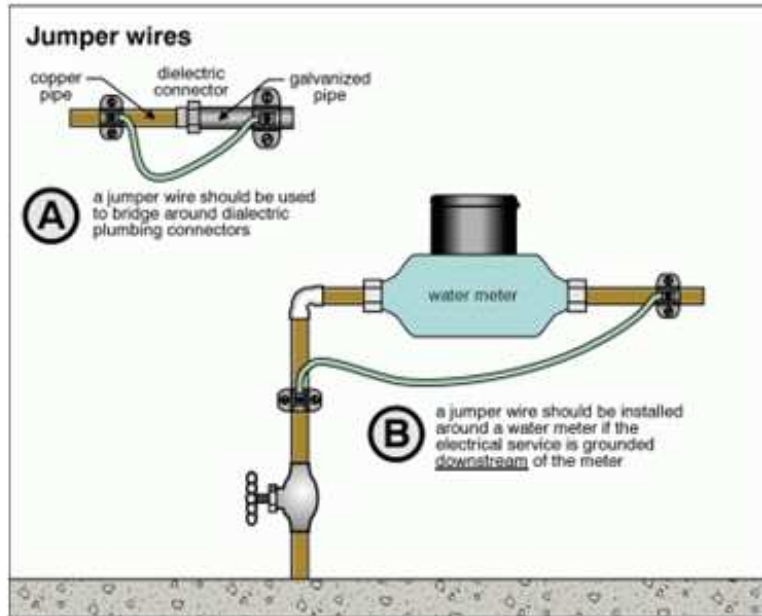
SERVICE BOX, GROUNDING AND PANEL \ System grounding

Condition: [No jumper for meters and valves](#)

Implication(s): Electric shock

Task: Repair

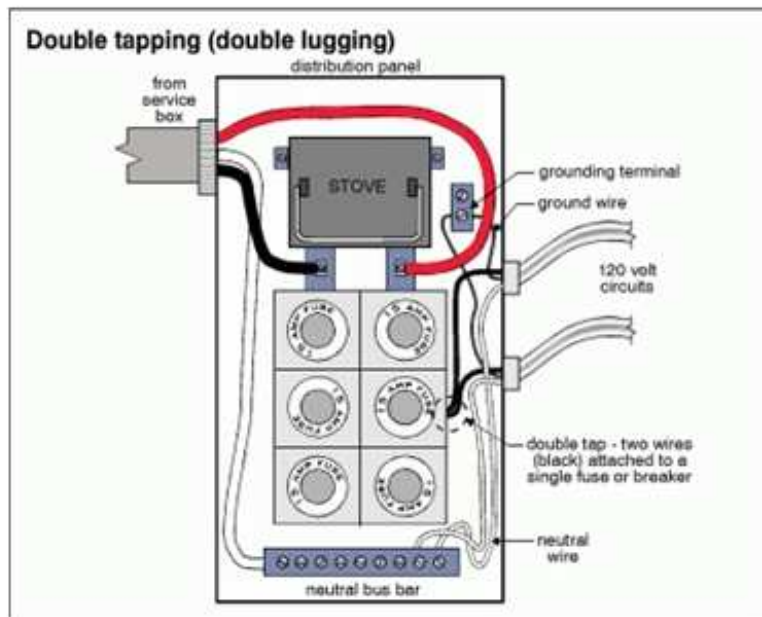
Condition: [Double taps](#)

Implication(s): Fire hazard

Task: Correct

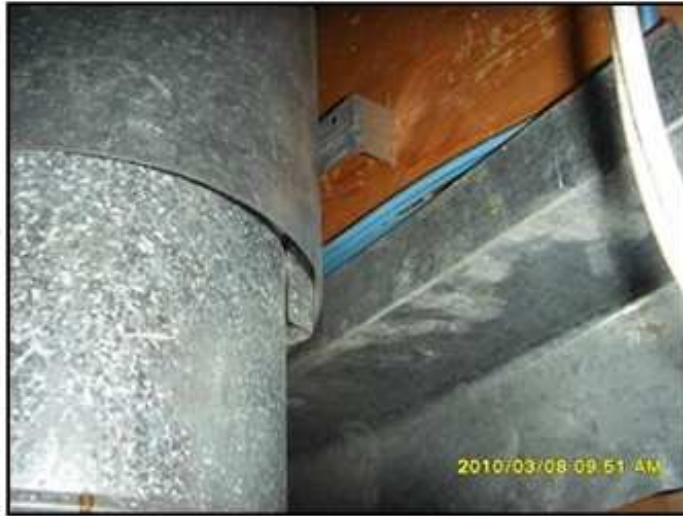
5.

Condition: [Too close to duct, pipe, vent or chimney](#)

Implication(s): Electric shock | Fire hazard

Location: Basement Furnace Room

Task: Correct

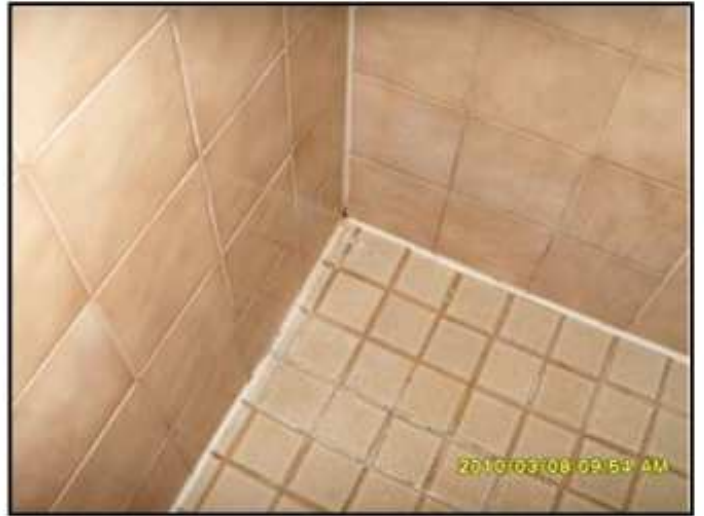
7.

Condition: [Entrance problems](#)

Latch on shower door broken

Implication(s): Difficult access

Task: Repair

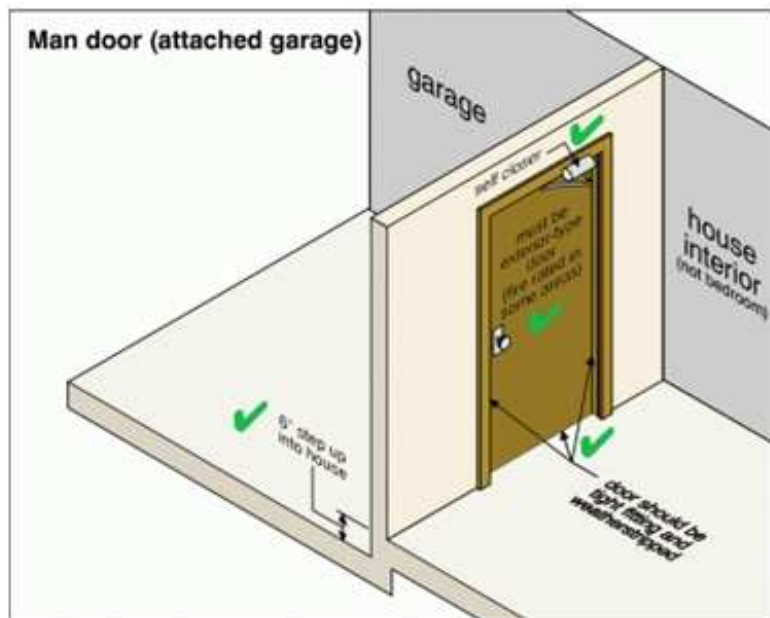
GARAGE \ Man-door into garage

Condition: [No self closer](#)

Implication(s): Hazardous combustion products entering home

Task: Replace

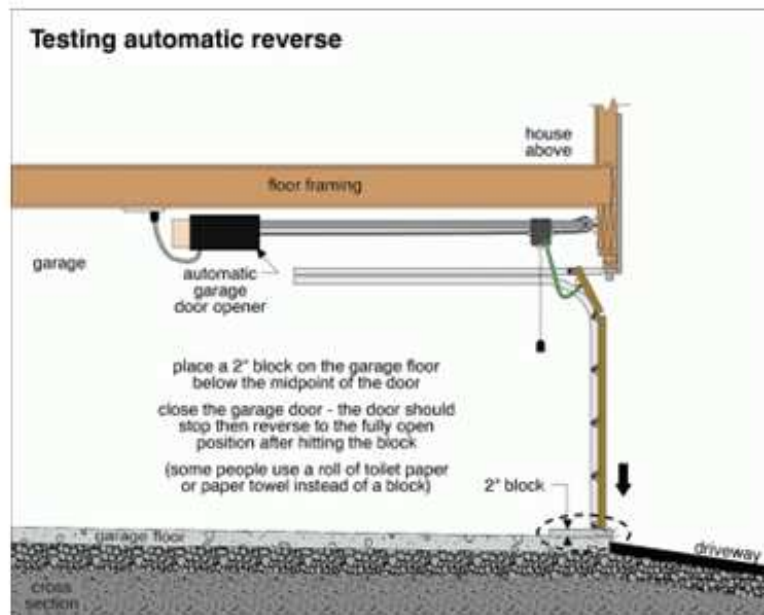
Condition: [Fails to auto reverse](#)

Implication(s): Physical injury

Task: Repair
